**A study of the effect of clinical washing decontamination process on corrosion resistance of Martensitic Stainless Steel 420**

**A Study of the Effect of Clinical Washing Decontamination  
Process on Corrosion Resistance of Martensitic Stainless  
Steel 420**

**ABSTRACT:**

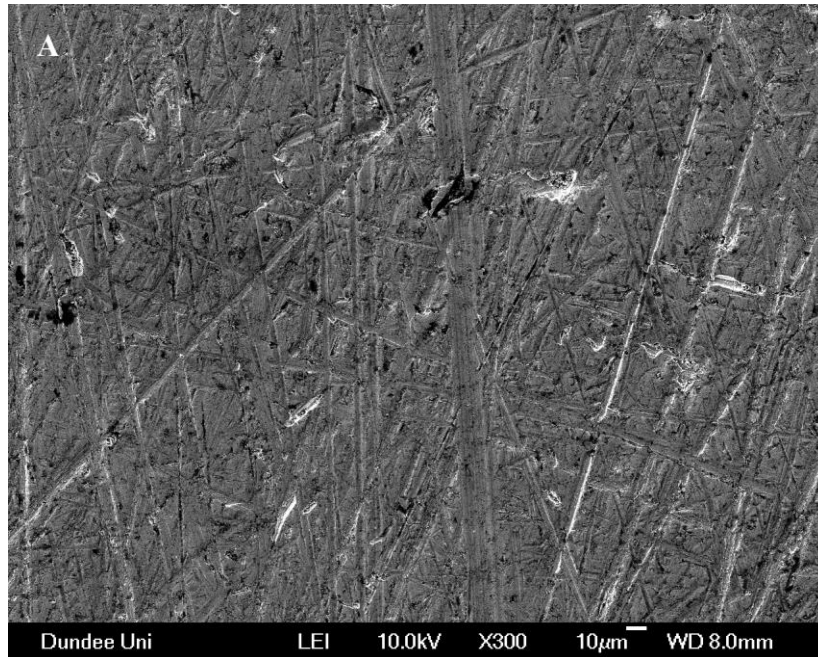
Fig.1 SEM pictures of different surface finishes (A) P320

SEM images taken of different polished surface finishes (Fig.1) indicated similar morphological features among all three polished samples except fewer and shallower scratches with the finer polishing grade. The bead blasted sample surface was not characterised by scratches but indentations left after blasting.

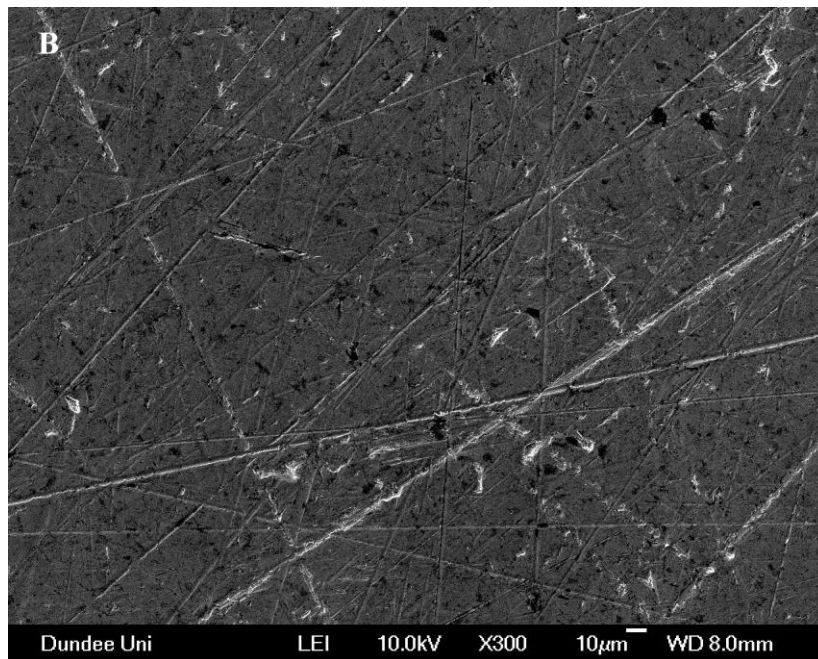
Fig.1 SEM pictures of different surface finishes (B) P600

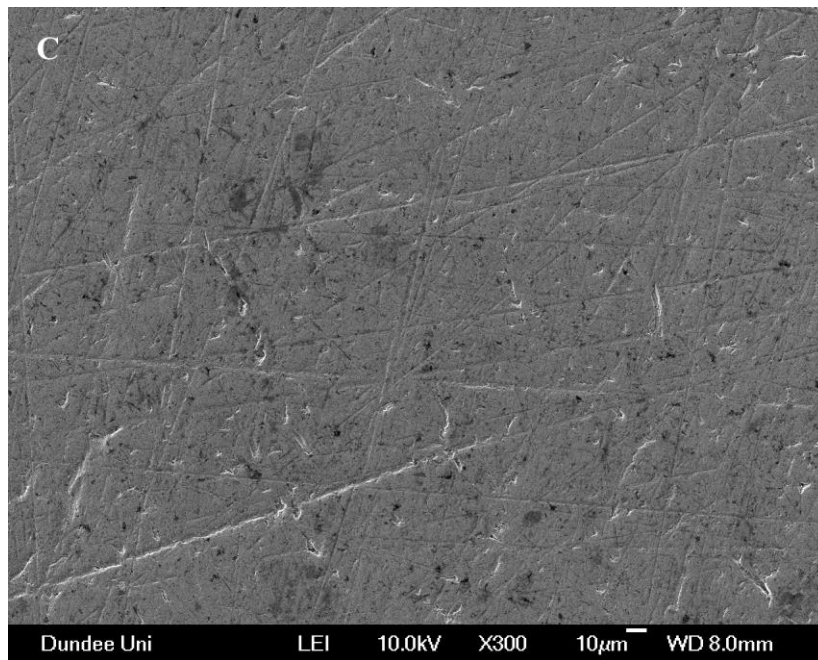
Fig.1 SEM pictures of different surface finishes (C) P1200

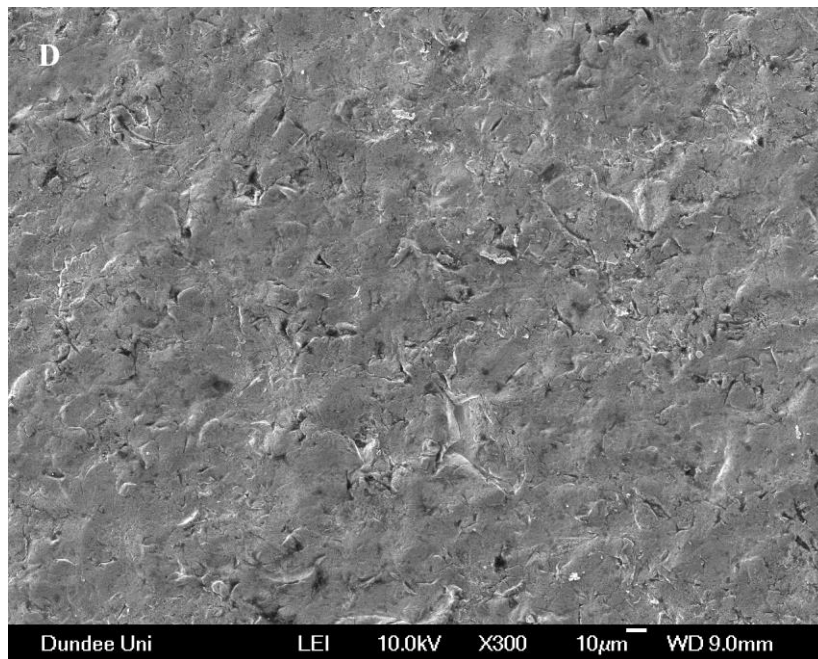
Fig.1 SEM pictures of different surface finishes (D) B10

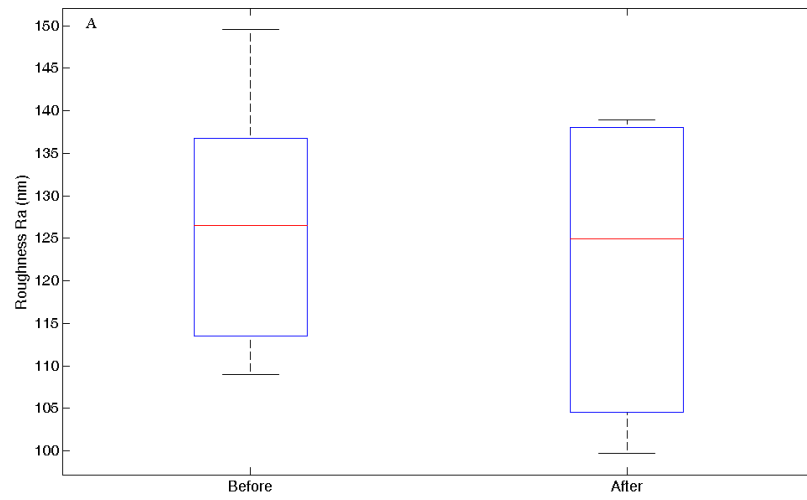
Fig.2 Roughness value of different surface finishes (A) P320

Although mean values of polished samples decreased slightly, both maximum and minimum values decreased significantly (Fig.2).

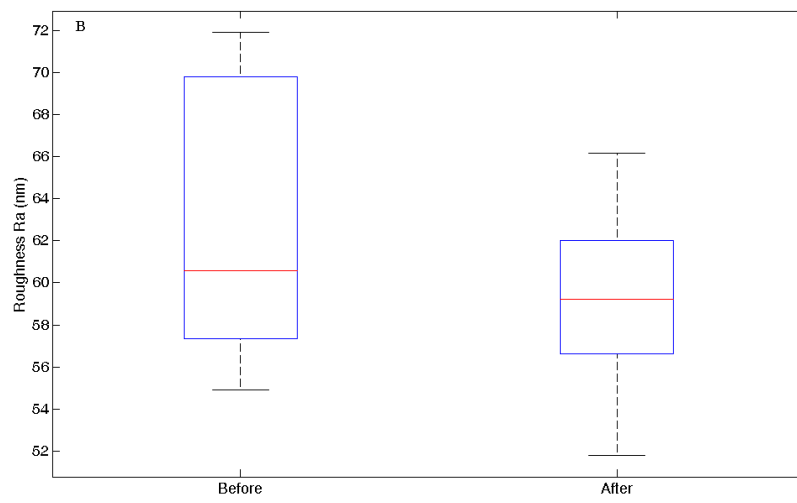
Fig.2 Roughness value of different surface finishes (B) P600

Comparing measurements before and after WD cycles, both P600 and P1200 displayed a smaller standard deviation, indicating a more uniform surface. Compared to polished samples, B10 has a minimal change in roughness as the value of Ra decreased for only 0.6% and its standard deviation covers a similar range.

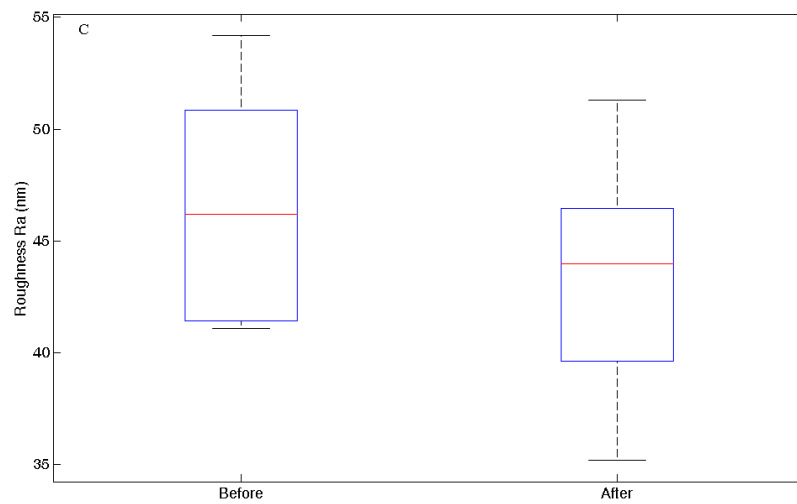
Fig.2 Roughness value of different surface finishes (C) P1200

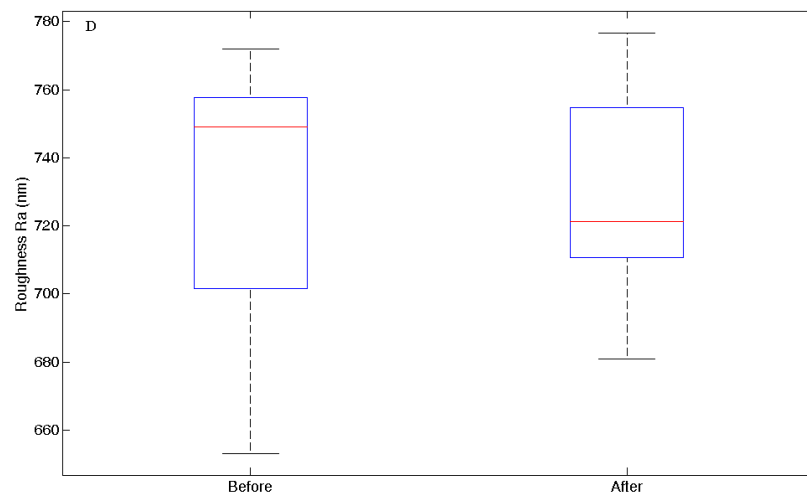
Fig.2 Roughness value of different surface finishes (D) B10

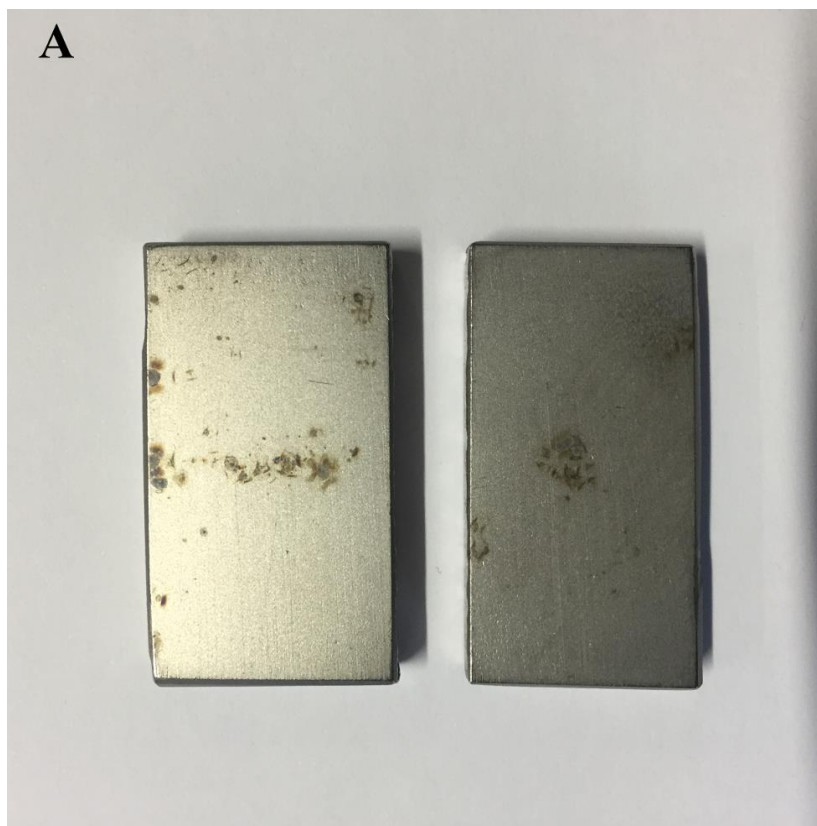
Fig.3 Corrosion observed on bead blasted sample after WD cycles (A)  
overview

After 150 WD cycles, all samples retained the same appearance except B10. Corrosion was observed on bead blasted samples. (Fig.3) However, it remains curious that only one side, that touching the washing basket during experiment, was corroded. It is suspected to be caused by the microenvironment formed between two materials (stainless steel sample and washing basket) because the corrosion occurred is galvanic corrosion instead of pitting corrosion.

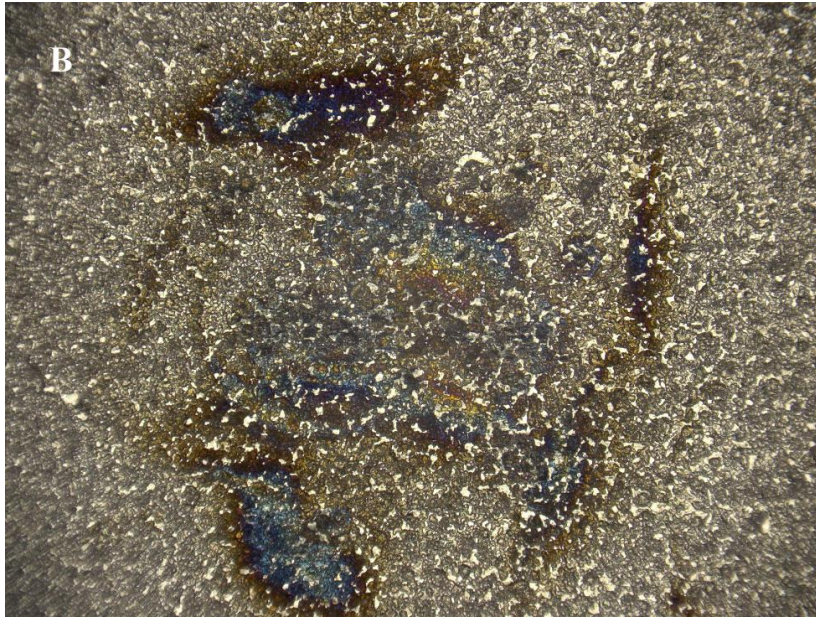
Fig.3 Corrosion observed on bead blasted sample after WD cycles (B)  
x100

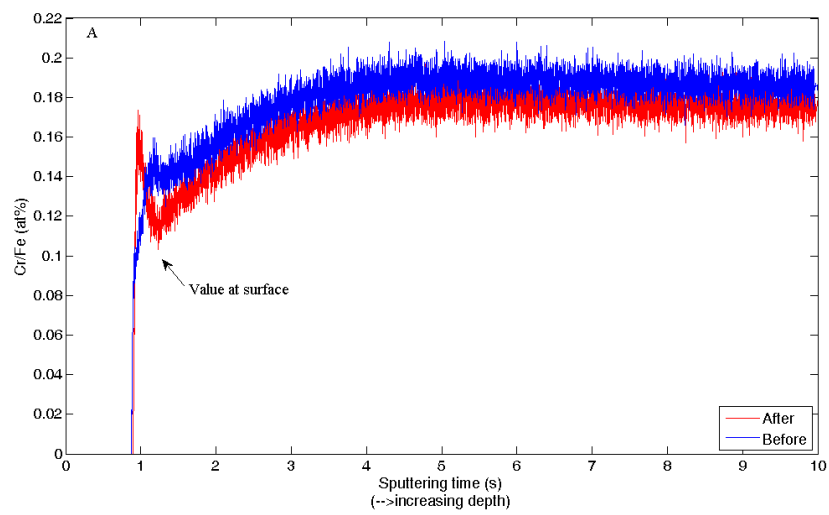
Fig.4 Cr/Fe value by sputtering time (A) P320

The time taken to sputter gives a measure of distance from the surface. The concentration of elements was detected before and after experiments and the Cr/Fe ratio was calculated to indicate the passivity of sample surface (Fig.4). The non-corroded area of sample B10 (Fig.4 (D)) was used in this experiment.

Among all samples, P1200 showed the most significant effect in Cr/Fe ratio increasing from 0.24 to 0.32, followed by P600, whose Cr/Fe ratio changed from 0.18 to 0.23. P320 displayed the least increase of the three polished samples with just more than 0.01. B10 has a minimal change in Cr/Fe ratio. Changes of Cr/Fe ratio caused by WD process only have an effect within a few microns of the surface (displayed on figures from 0.8s to about 1.2s), before the

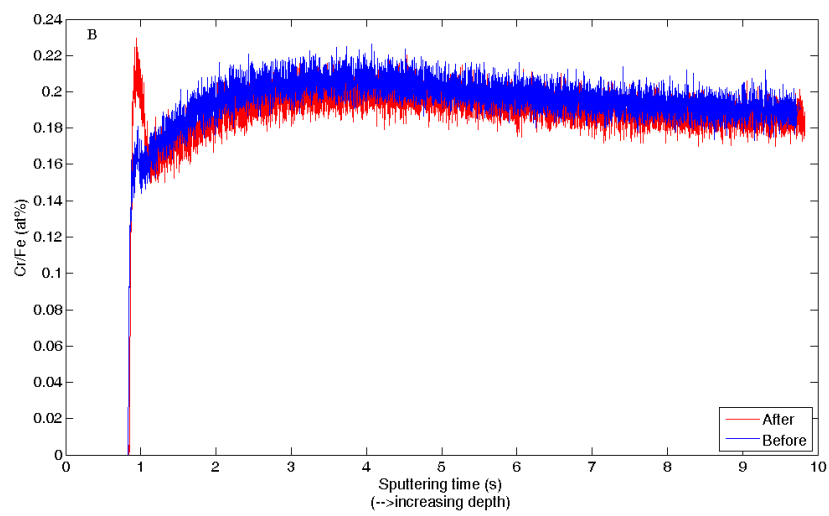
Fig.4 Cr/Fe value by sputtering time (B) P600

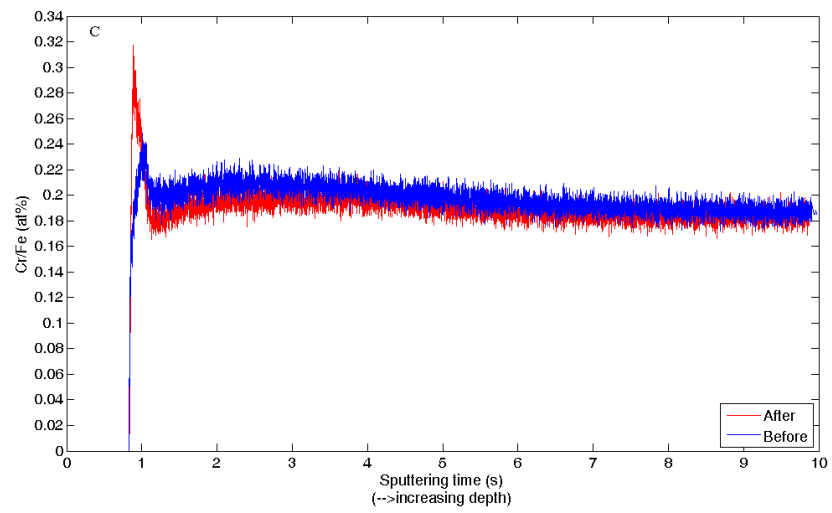
Fig.4 Cr/Fe value by sputtering time (C) P1200

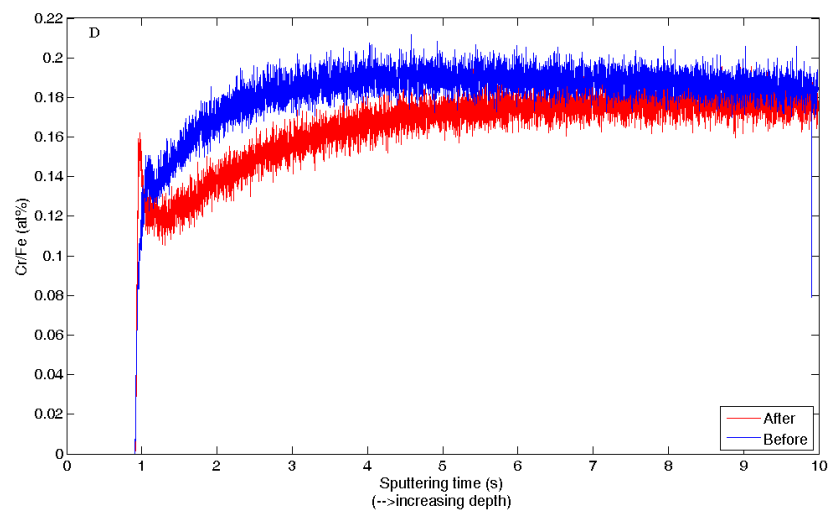
Fig.4 Cr/Fe value by sputtering time (D) B10
